# Q400 *DASH 8*

## IN-SERVICE ACTIVITIES REPORT

ISAR 2007-06

JUNE 21, 2007

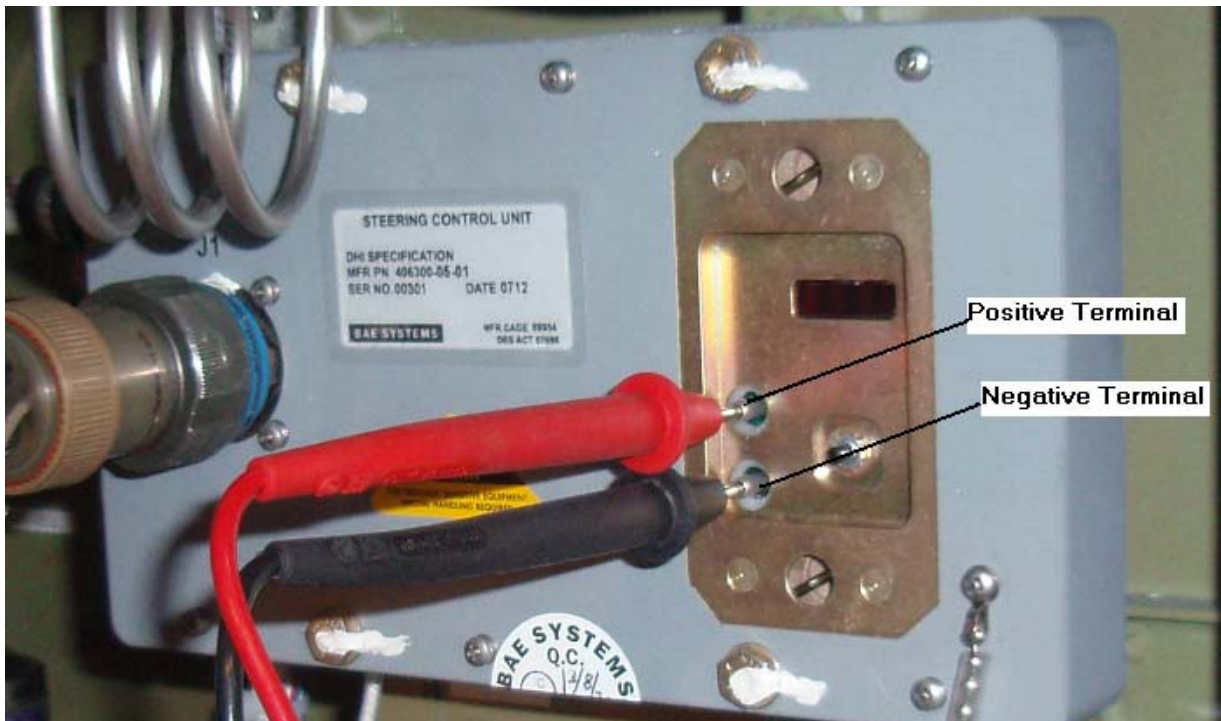
It has been reported that the test jacks located on the front face of the steering control unit are not identified POSITIVE and NEGATIVE.

When performing the rigging function of the RVDTs (ref. AMM Task 32-51-00-830-801), operators are advised that, when measuring the output voltage, the **upper** test jack is POSITIVE and the **lower** test jack is NEGATIVE.

A Manual Change Request (MCR) has been raised to amend the rigging task, adding a note in the procedure to identify the polarity of each test jack.
